FINAL REPORT JANUARY 2001

REPORT NO. 00-07

2.75-INCH TRAINING ROCKET, PA150 CONTAINERS ON WOODEN PALLETS WITH METAL TOP LIFT, MIL-STD-1660 FIRST ARTICLE TEST (FAT)

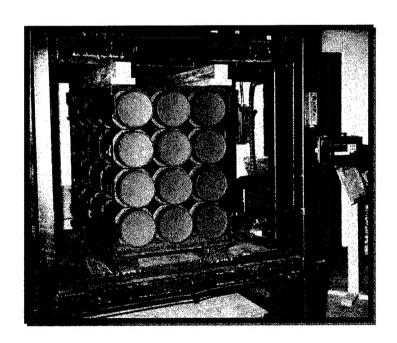
<u>Figure 1.</u> Example of Compression Tester.

(2.75-inch Hydra 70, PA151 Rocket Pallet in the compression tester.)

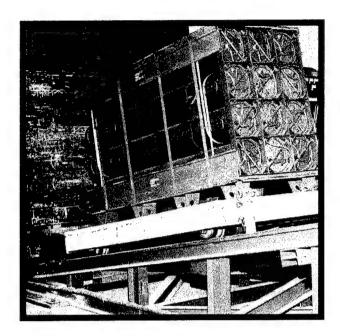
Figure 4. Example of the Incline-Impact Test.

(2.75-Inch, Hydra 70, PA151 Rocket Pallet on Incline-Impact Tester.)

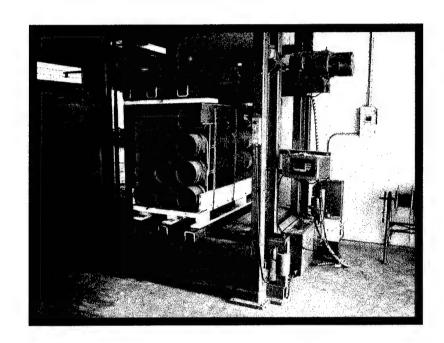
Figure 5. 2.75 –Inch Training Rocket, PA150 Container on Wooden Pallets with Metal Top Lift, Test Pallet 3 on the Compression Tester.

1. <u>Compression Test</u>. Test Pallet 3 was compressed with a load force of 9,900 pounds for 90 minutes on 19 December 2000. No damage was noted as a result of this test. See Figure 5 for Test Pallet 3 in compression.

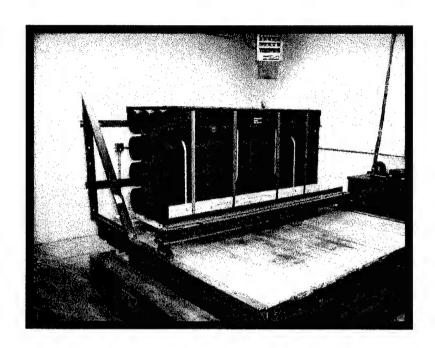
<u>Figure 6.</u> 2.75 –Inch Training Rocket, PA150 Container on Wooden Pallets with Metal Top Lift, Test Pallet 3 on the Vibration Table.

2. <u>Repetitive Shock Test</u>. Test Pallet 3 was vibrated 90 minutes at 135 RPM in the longitudinal orientation and 90 minutes at 215 RPM in the lateral orientation. No damage was noted as a result of this test. See Figure 6 below.

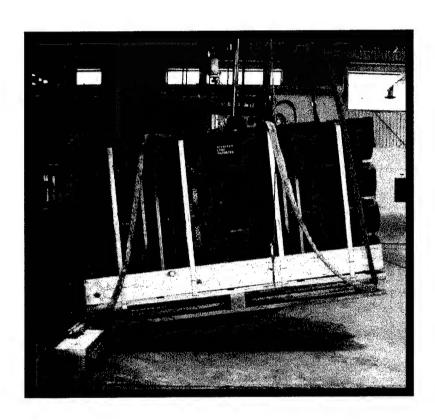
Figure 7. 2.75 –Inch Training Rocket, PA150 Container on Wooden Pallets with Metal Top Lift, Test Pallet 3

3. <u>Edgewise Rotational Drop Test</u>. Test Pallet 3 was edgewise rotationally dropped from a height of 15 inches on the longitudinal and 15 inches on the lateral drops. Minor board splitting in the bottom pallet boards was noted. No other problems were encountered. See Figure 7 for the drop test setup.

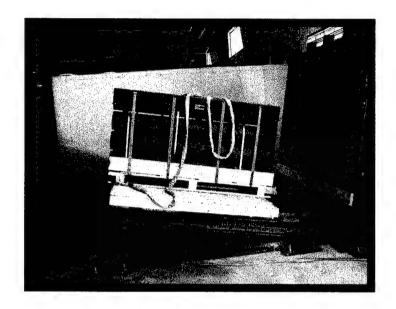
Figure 8. 2.75 –Inch Training Rocket, PA150 Container on Wooden Pallets with Metal Top Lift, Test Pallet 3

4. <u>Incline-Impact Test</u>. Test Pallet 3 was incline-impacted on all four sides with the pallet impacting the stationary wall from a distance of 8 feet. Again, no problems were encountered.
